Primary Name	Location Address	City	County	Postal Code
DALTON CORPORATION WARSAW MANUFACTURING FACILITY	1900 E JEFFERSON ST	WARSAW	KOSCIUSKO	46580

Re: Violation Letter  
Dalton Corporation/Warsaw  
IND 005 146-022  
Warsaw, Kosciusko County

Type of Inspection:	<u>X</u>	Compliance Evaluation Inspection
	<u>    </u>	Complaint
	<u>X</u>	Other: <u>Restricted Waste Site Inspection</u>
Results of Inspection:	<u>    </u>	No violations were observed
	<u>    </u>	Additional information and review is required to evaluate overall compliance.
	<u>X</u>	Violations were observed and will be referred to the Office of Enforcement. See inspection report.

The restricted waste site is permitted as a Type II landfill for the disposal of wastes generated by Dalton's foundry operations. The total acreage of the facility is 156 acres with 68.4 acres permitted as a Type II landfill. The facility is currently filling in all three Phases and has not minimized the working face of the landfill. Intermediate cover has only been applied to the western edge of Phase 1 and the southern edge of Phase 2. There are many areas that have not received waste within one year and have not received intermediate cover. Cu

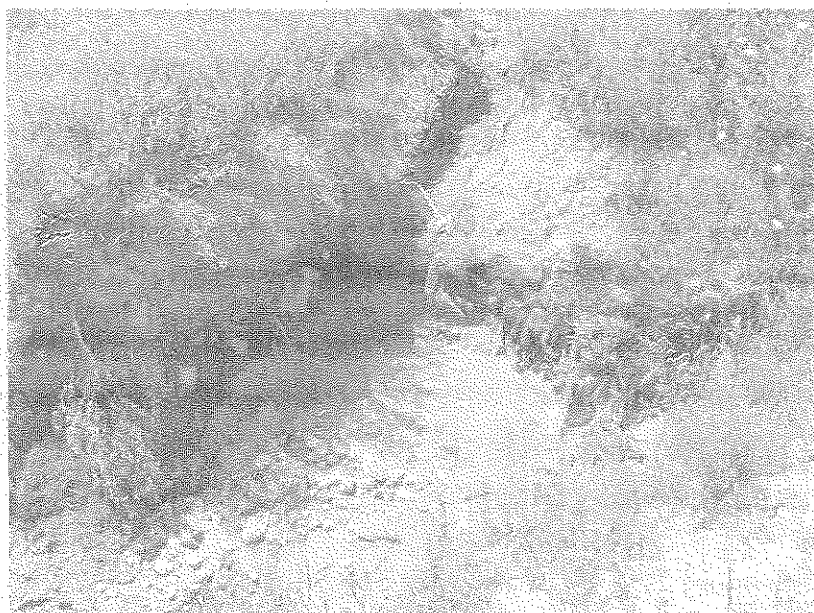
**Photo 29**

**Location and Subject:** Northeast side of Phase 2 – Large erosion cut through the cap, buried waste, and into the bottom clay liner. The ravine was approximately 12 feet deep and discharges to the wetland north of the fill area.

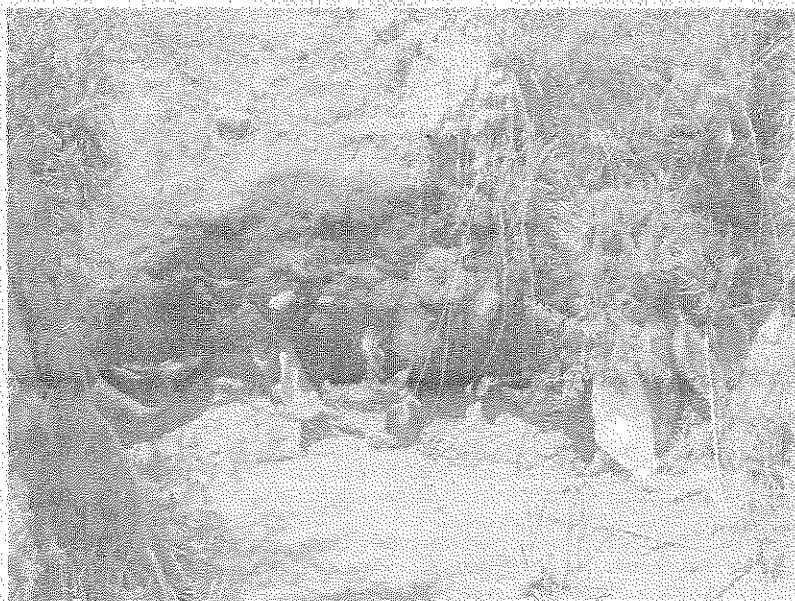
**Photo 30**

**Location and Subject:** Northeast side of Phase 2 – Close up of the erosion cut showing the exposed waste and damage to the bottom clay liner.

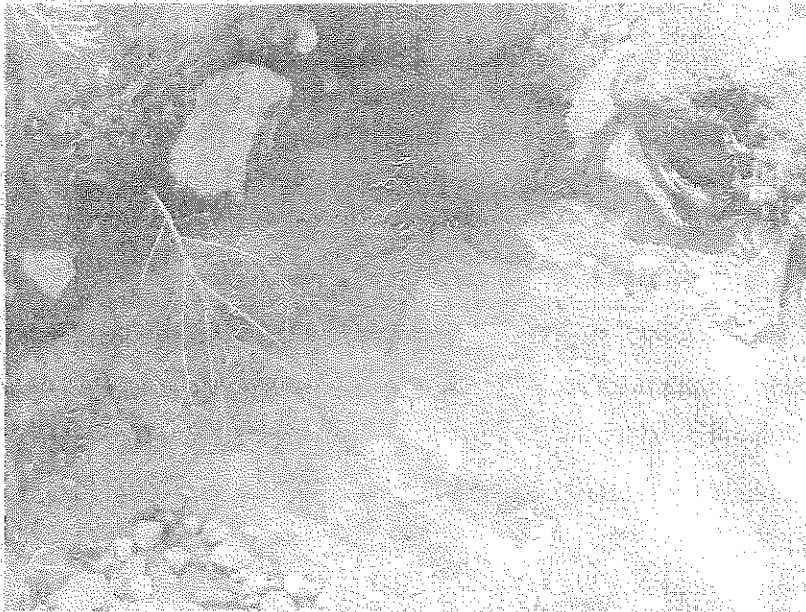
**Photo 31**

**Location and Subject:** Northeast side of Phase 2 – Close up of the erosion cut showing the exposed waste and damage to the bottom clay liner.

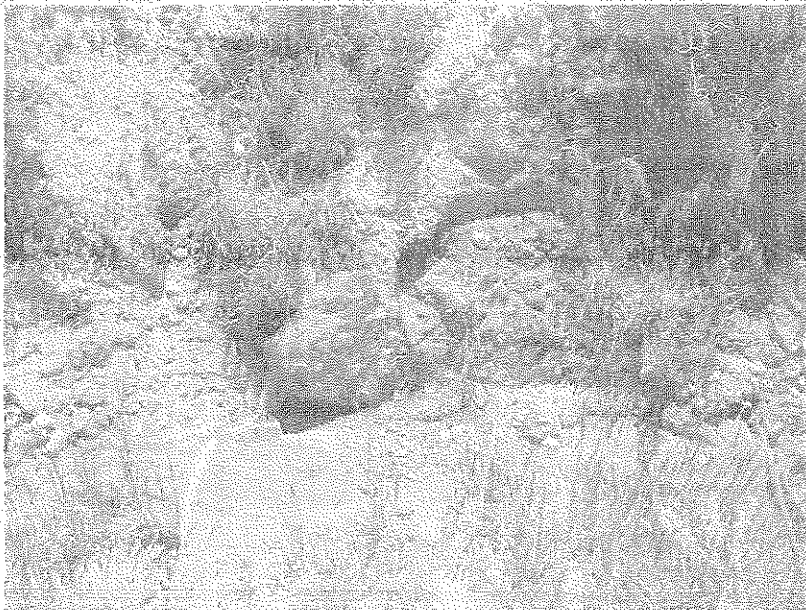
**Photo 32**

**Location and Subject:** Northeast side of Phase 2 – Close up of the erosion cut showing exposed waste.

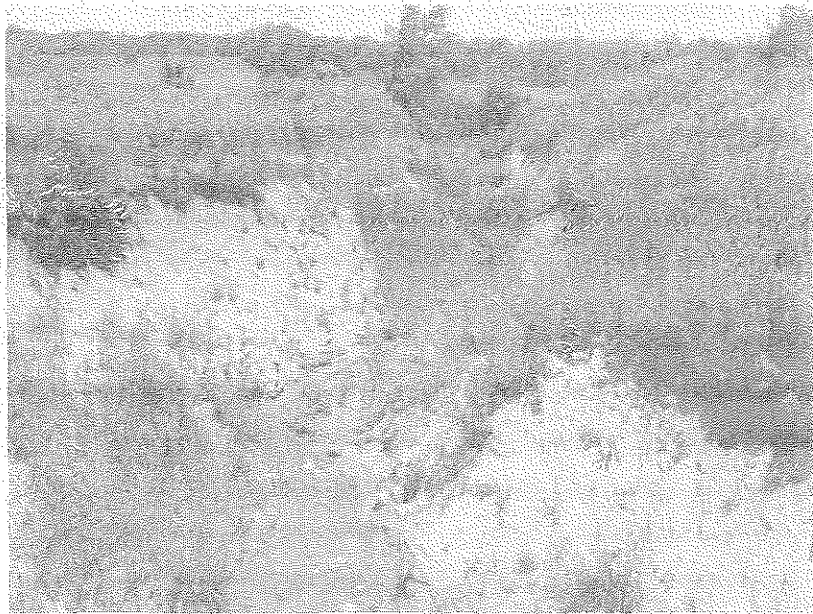
**Photo 33**

**Location and Subject:** East side of Phase 2, facing north -- Erosion cut discharging waste and sediment into the wetland to the north of the fill area.

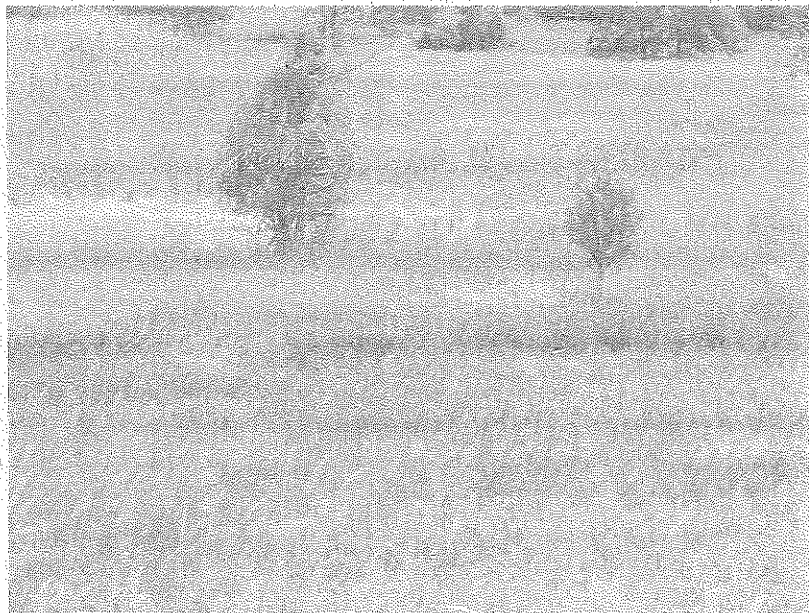
**Photo 34**

**Location and Subject:** Unconstructed area of Phase 3 -- Sedimentation in the wetland area from the large erosion cut on the northeast side of Phase 2.

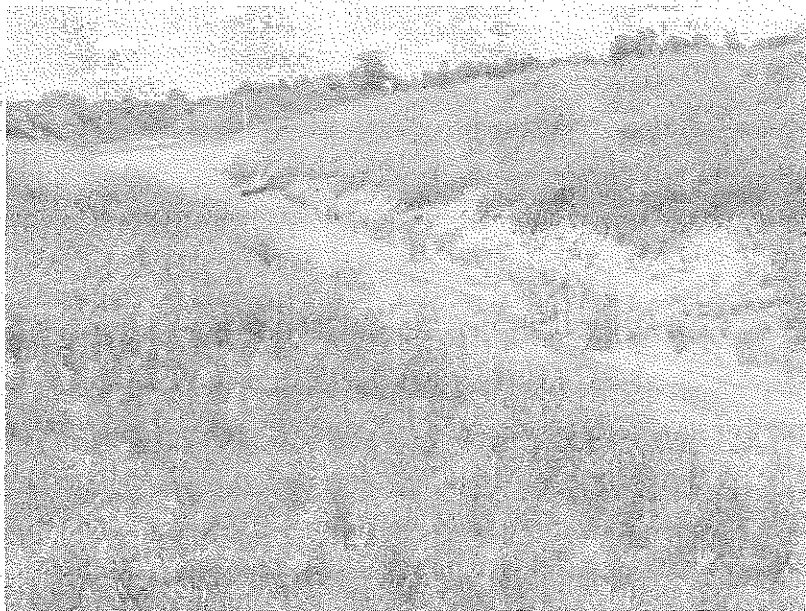
Photo 35

**Location and Subject:** North of Phase 3, Section 1, facing south – Drainage ditch receiving leachate from the active fill area.

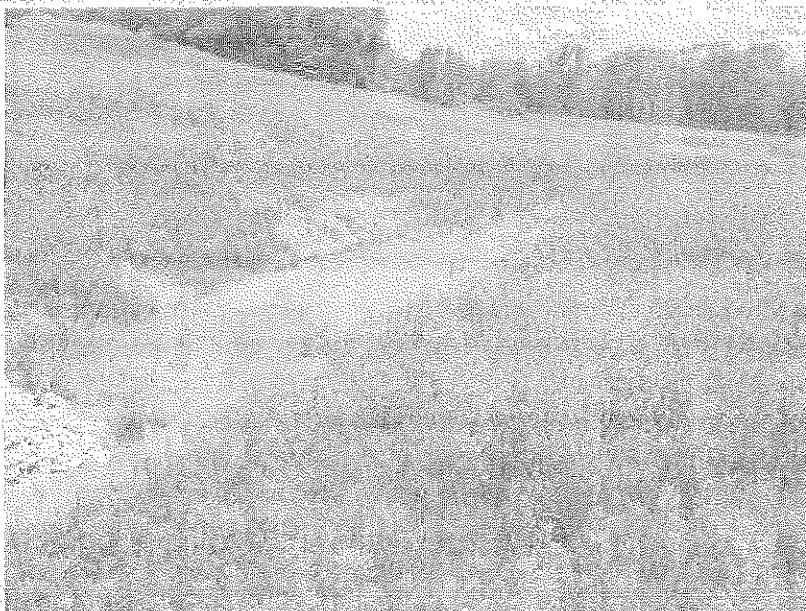
Photo 36

**Location and Subject:** North of Phase 3, Section 1, facing north – Drainage ditch receiving leachate from the active fill area and discharging to the wetland area and Boggs Ditch.

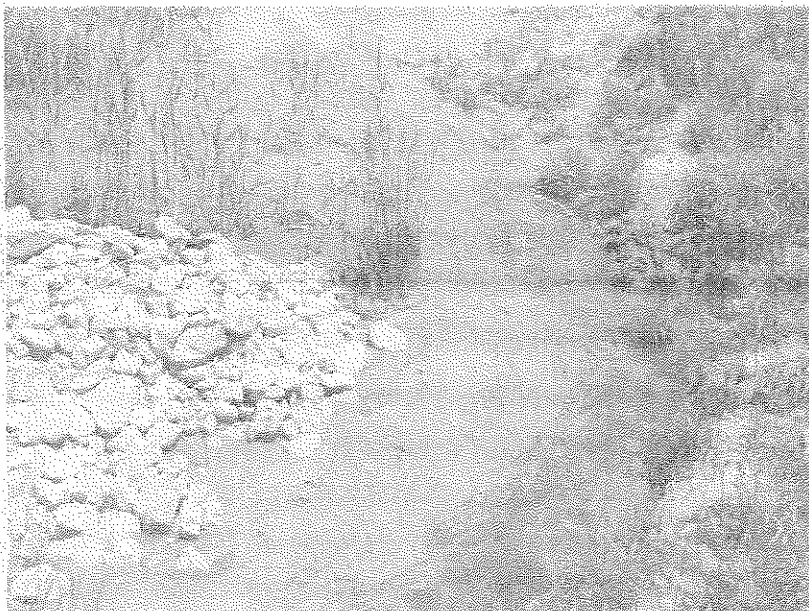
**Photo 37**

**Location and Subject:** North of Phase 3, Section 1, facing north – Damaged check dam allowing leachate from the active fill area to discharge to the wetland area and Boggs Ditch to the north.

After receipt of the Letter, Dalton repaired the check dam in Phase 3, Section 1 and constructed three additional dams so that if the flowing water manages to get past one dam, the flow will be slowed by one of the subsequent dams. The erosion that occurred this spring and early summer was worse than in most years. Northern Indiana had several torrential rainfall events where a lot of rain fell in a very short period of time. (The fact that the erosion occurred in 2008 is supported by the fact that Mr. Schafer's written quarterly inspection reports from 2007 never mention erosion as a problem). The damage caused by the erosion was repaired as soon as the weather allowed and equipment was available. In fact, most of the erosion damage has now been repaired. In addition, in the area where the erosion was the worst-- in the NE corner-- Dalton has repaired the intermediate cover so that the water will be redirected to a newly constructed swale-like area lined with rip rap that will help to prevent any further erosion in the future. Mr. Espich's contention that Dalton is now required to apply daily cover is not valid. Dalton will continue to apply intermediate cover as required pursuant to its permit until directed differently.

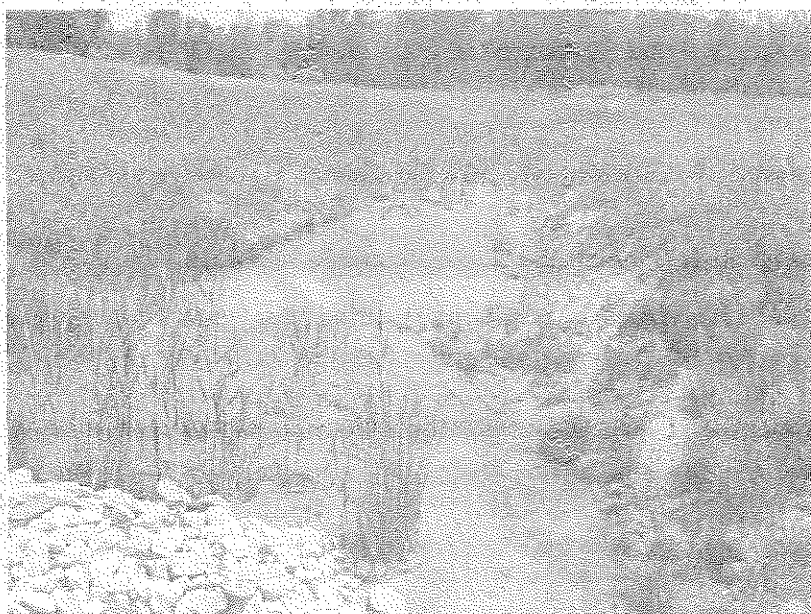
**Photo 38**

**Location and Subject:** North of Phase 3, Section 1, facing north – Damaged check dam allowing leachate from the active fill area to discharge to the wetland area and Boggs Ditch to the north.

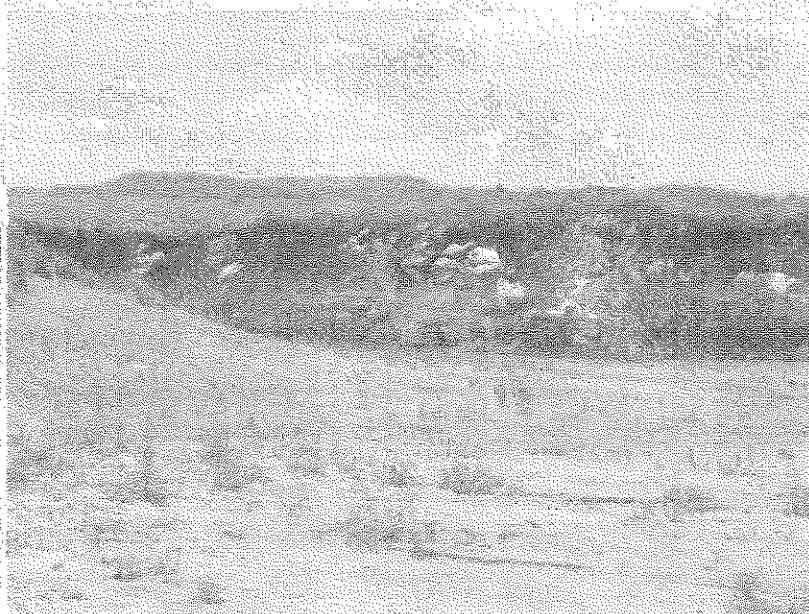
**Photo 39**

**Location and Subject:** Northeast side of Phase 3, Section 1, facing south -- Active fill area.
